**No. 81-31**

## Anti-Siphon Devices Used In Conjunction With MerCruiser Engines

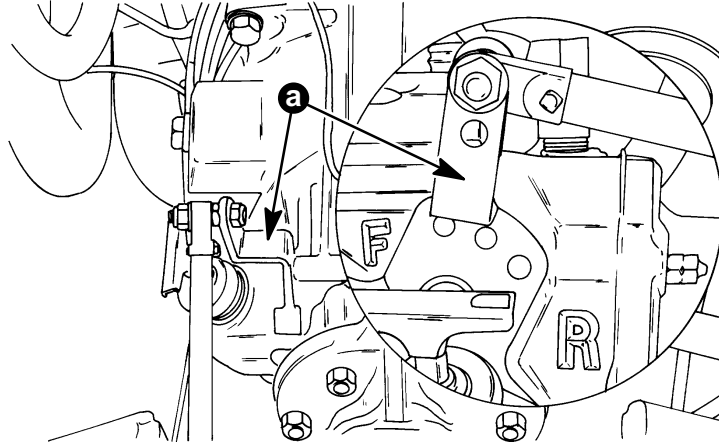
**Figure 1. Transmission Shift Lever**

a - 71-79B Shift Lever

The shift lever that is used on the Borg-Warner transmission, on the above model engines, is not available from Mercury Marine. If a replacement shift lever is required, order Part No. 71-79B from a Borg-Warner Distributor or dealer.
